**KM2164 & KM2542
INSTALLATION INSTRUCTIONS**

Kawasaki Mule CV Boot / A-Arm Guards

Fits Kawasaki Mule 610 & SX 4x4; 2005 & Newer

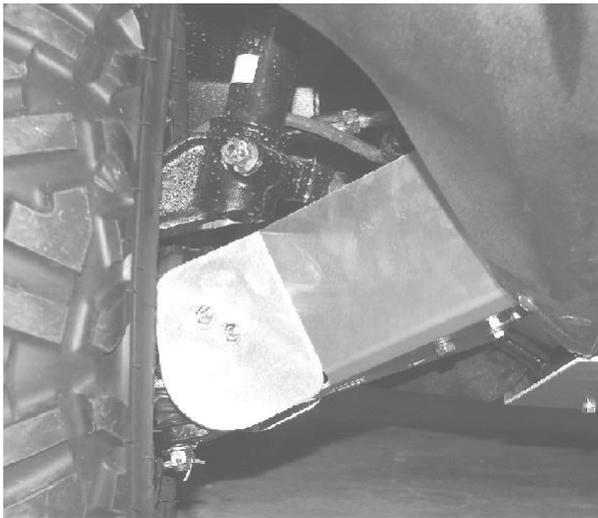
CV Boot Guard Installed

Thunderhawk Performance has designed our CV Boot / A-Arm Guards to offer maximum protection for the CV boots and the A-arms on the Kawasaki Mule 610. These CV Boot Guards feature an extra-large, reinforced front deflector to provide the best CV boot protection available. The Thunderhawk Performance reinforced deflector design ties into the factory-installed small-diameter wire stick guards on the outer ends of the A-arms to provide additional strength and stiffness. These small-diameter wire stick guards are visible in the “No Protection” photo above.

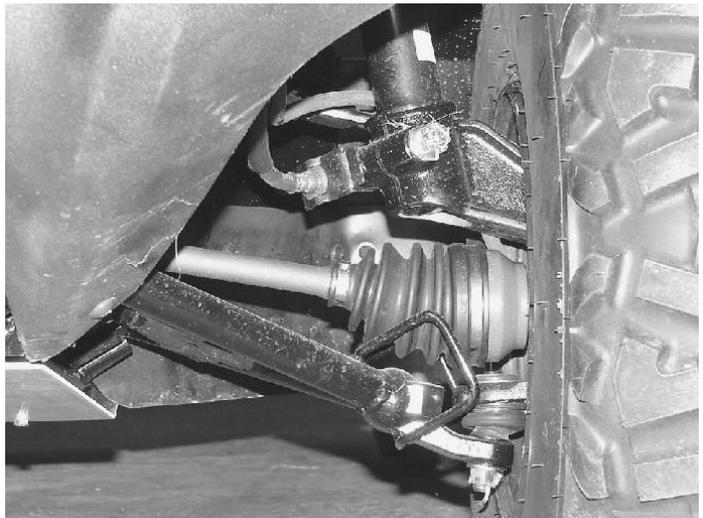
No Protection

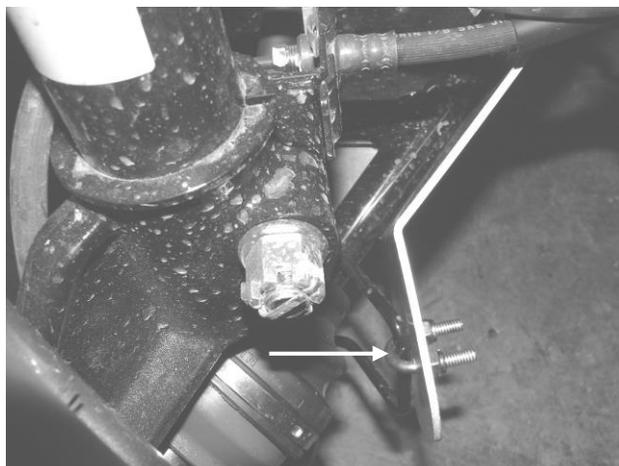
4. To secure the front deflector on the CV Boot Guard, install the supplied U-bolt over the wire stick guard (from the back side of the CV Boot Guard) with the threaded ends of the U-bolt extending through the CV Boot Guard toward the front (as shown in photo at right). Install the supplied 1/4" flat washers and nylon lock nuts on the U-bolt and tighten. On KM2164, repeat for the installation of the U-bolt on the rear of the CV Boot Guard.
